Fatigue Fracture of the Femoral Neck and Compression Screw in the Treatment of Hip Dislocation with a Pipkin II Femoral Head Fracture

Fatigue fracture; Pipkin II; Screw fracture

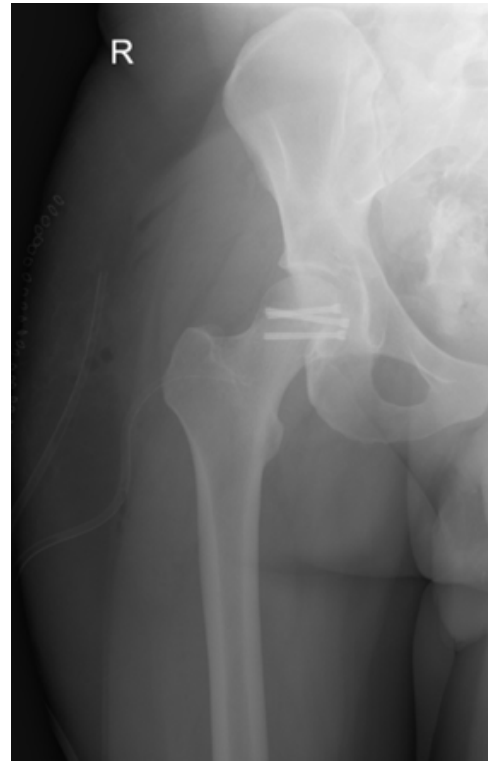
The anatomical positioning of the hip joint components can be seen in the postoperative radiograph (Figure 2).

Figure 2: Anterior -posterior X-ray of the hip joint after surgery.

The fracture fragments were then repositioned and stabilized-using Arthrex headless compression screws.

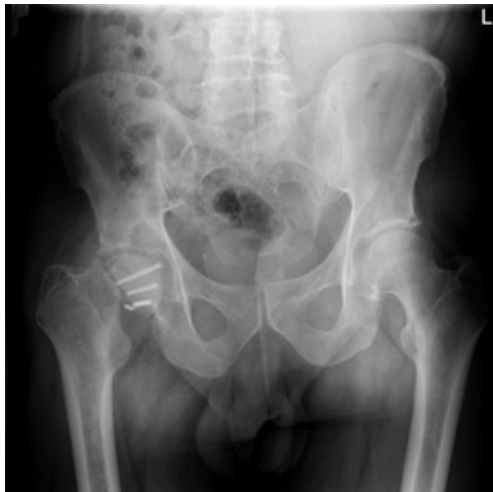
Eleven months after surgery, the patient returned to the orthopedic clinic due to pain in the groin, yet denied any injury to the operated limb. The follow-up radiographs revealed a fracture of the femoral neck together with a fracture of the screw stabilizing the femoral head. Although the cause of the fracture remains unknown–it may have been related to recent -stay in the mountains during which the patient took park in long walks over a number of days, which may have led to a fatigue fracture (Figure 3).

edge of the greater trochanter and the large lateral muscle was moved posteriorly. Finally, a T-shaped incision was made in the joint capsule. Examination revealed the presence of a subcapital fracture of the femoral neck, damage to the implants fixing the fracture, and bone fusion of the broken part of the femoral head.

Figure 3: Anterior -posterior X-ray of the hip joint 11 months after the surgery.

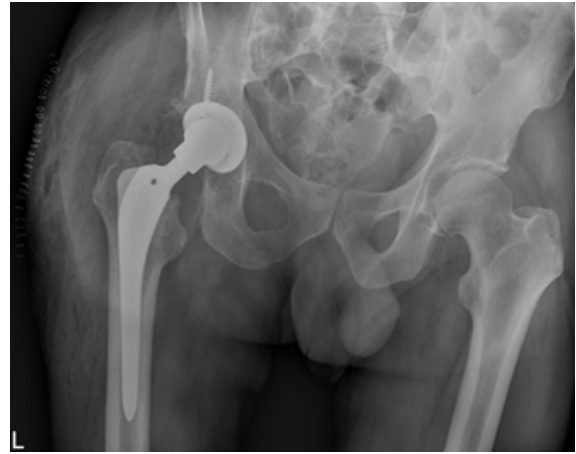
Figure 4: Anterior posterior X-ray after hip arthroplasty surgery.

The femoral head and implants from the previous surgery were removed. The neck was cut about 1.5 cm above the lesser trochanter. A spherical surface without cartilage was prepared for attachment of the acetabulum using slow-speed spherical reamers. After obtaining a stable seating for the acetabular implant, an anti-rotation sponge screw was used: it was decided to use a polyethylene insert with a 15 'highwall' gradient at 10 o'clock to minimize the chance of dislocation of the joint. The seats were then prepared for the prosthesis stem, which was stably seated in the bone canal. As a number of periarticular adhesions were still present -following the previous surgery, it was decided to use a long head to increase the so-called offset and minimize the risk of dislocation. Both surgical procedures were performed by the senior author (JF) (Figure 4).

In the present case, a prosthesis with the Bicontact S stem and the Plasmacup cup was chosen for its longevity, and to provide the chance of a "lifetime prosthesis" [10]. Following installation, the patient was able to return to normal physical activity, even after such a severe injury as joint dislocation hip fracture with femoral head fracture complicated by fatigue fracture of the femoral neck.
